PHOTOGRAPHIC LOG

PHOTOGRAPH LOG ROLL 10
AMERICAN CHEMICAL SERVICES

ROLL #11 PHOTOGRAPH LOG
AMERICAN CHEMICAL SERVICES
12 March to 16 March 1990

ROLL #12 PHOTOGRAPH LOG
AMERICAN CHEMICAL SERVICES
19 MARCH TO 26 MARCH 1990

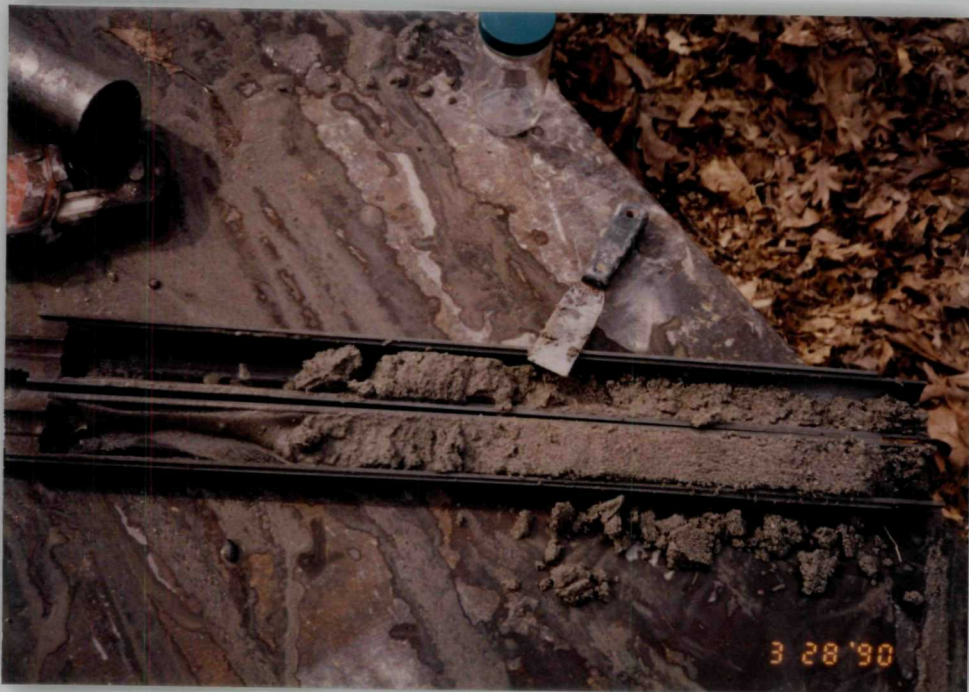
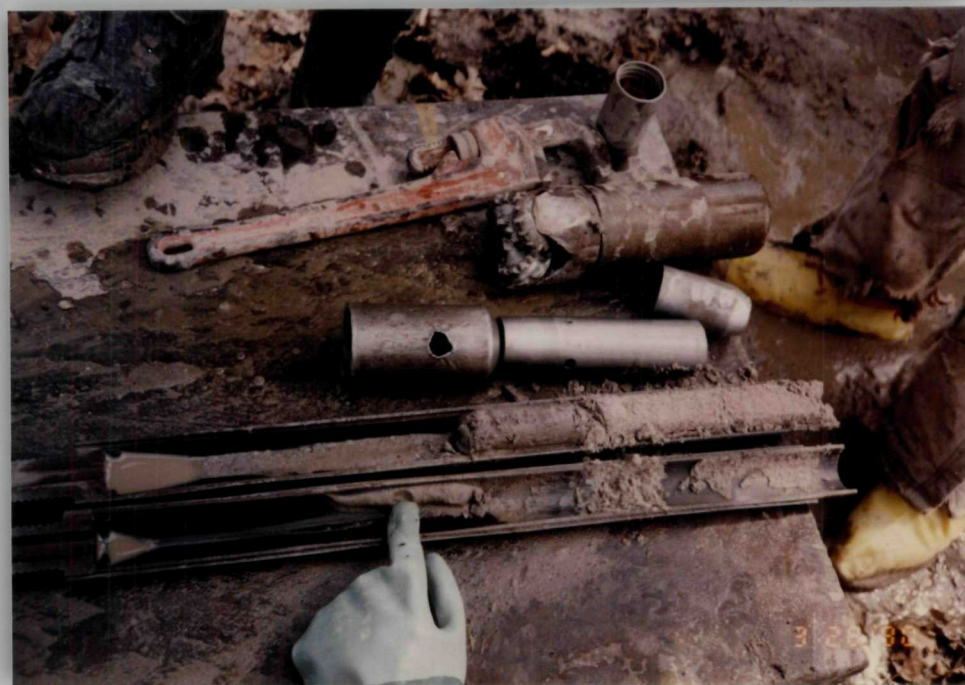
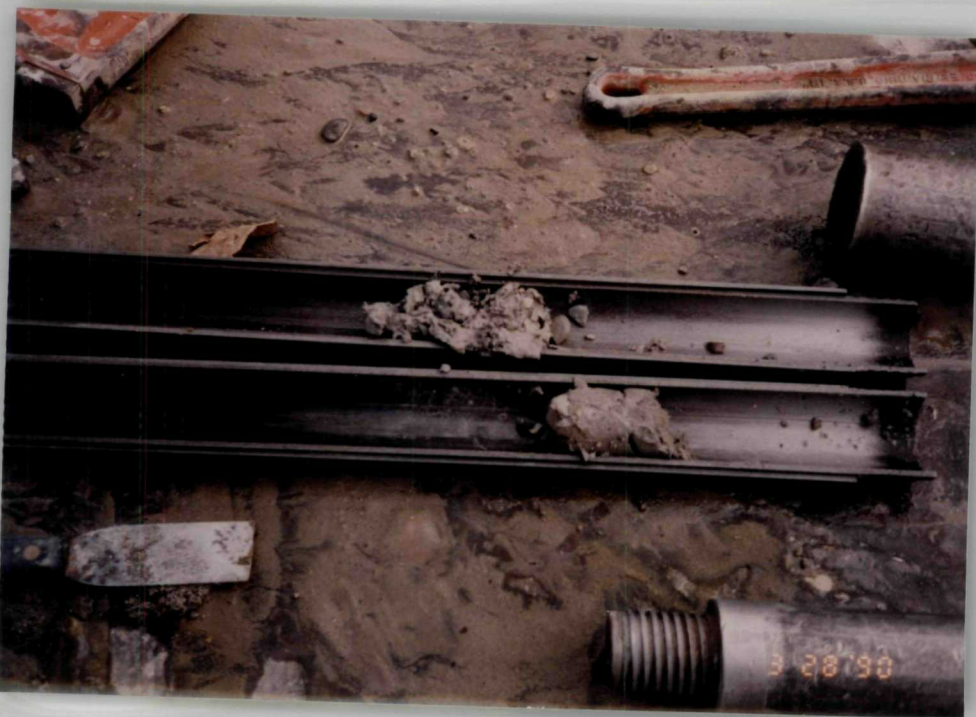
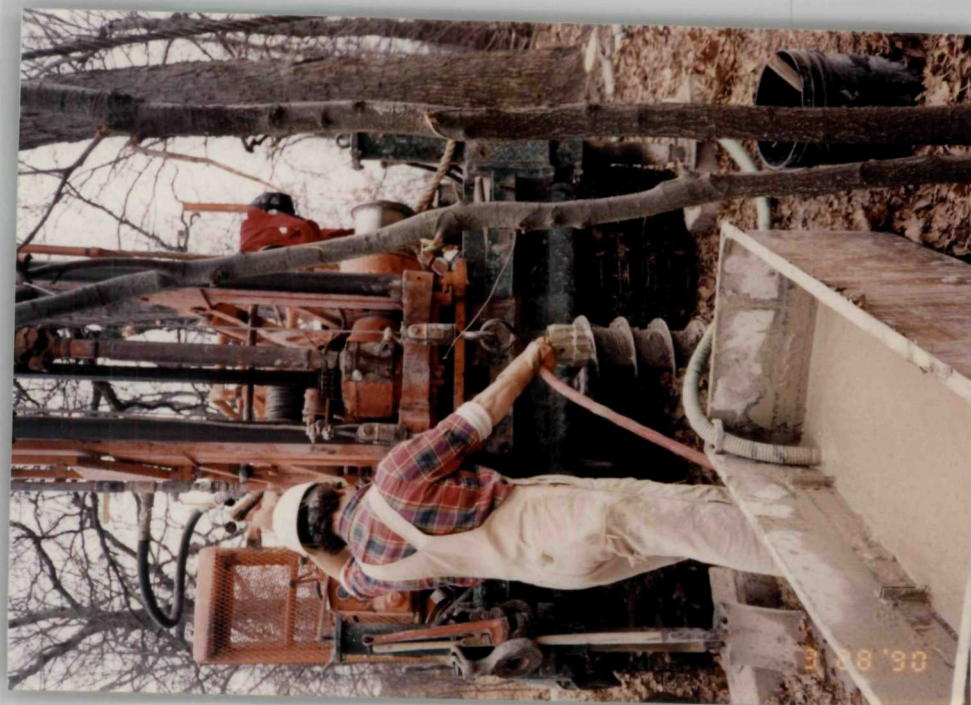
| Number | Description | Date |
|---|--|---|
| R13-15 | Split spoon sample of MW-10B, 19 to 21 feet. | 3/28/90 |

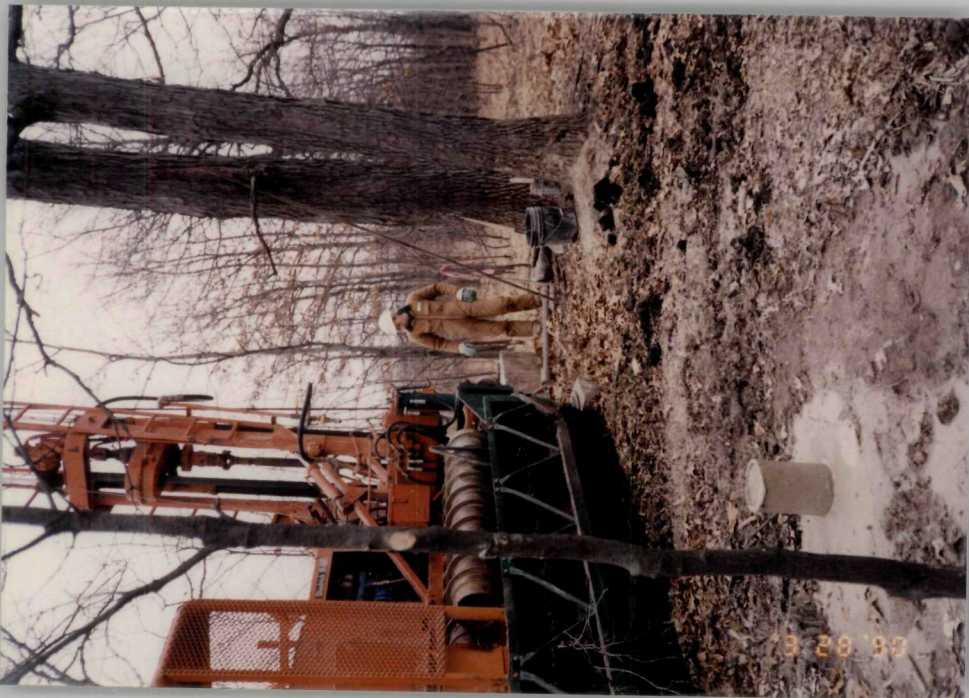
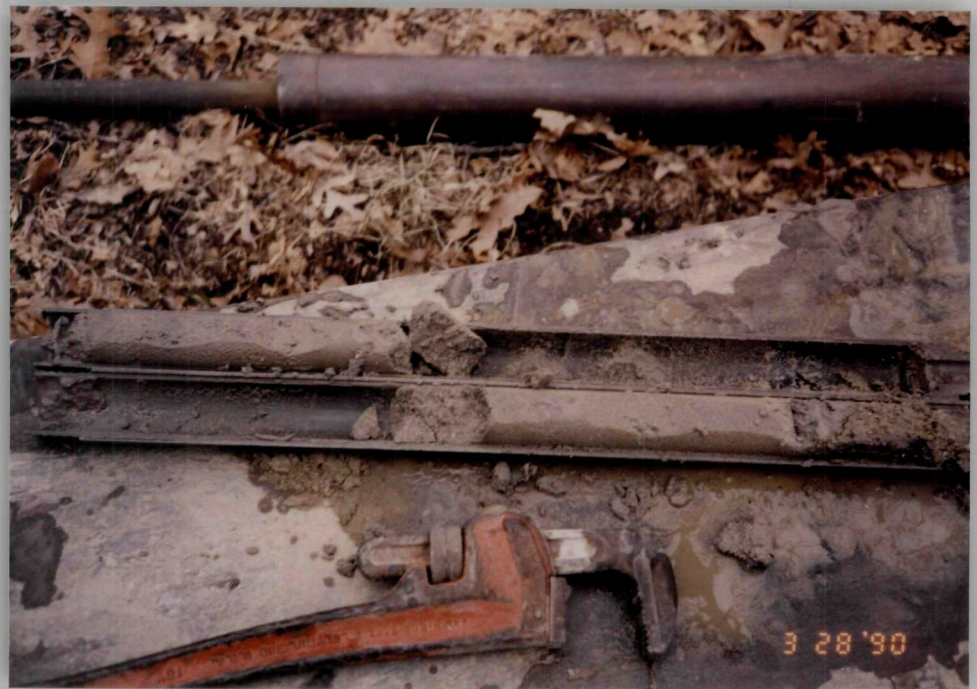
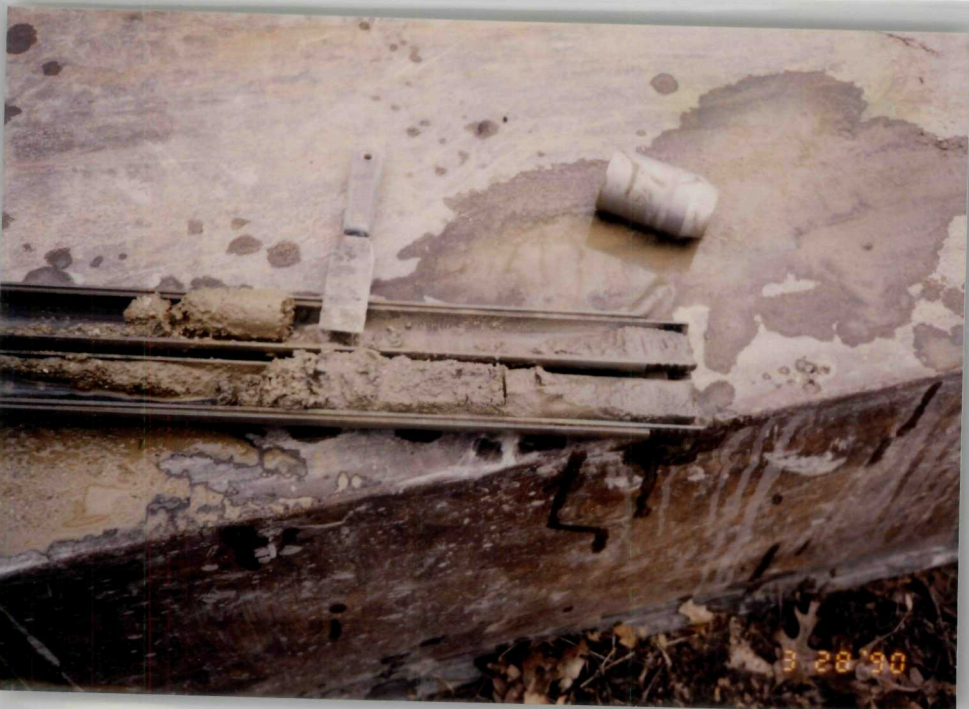
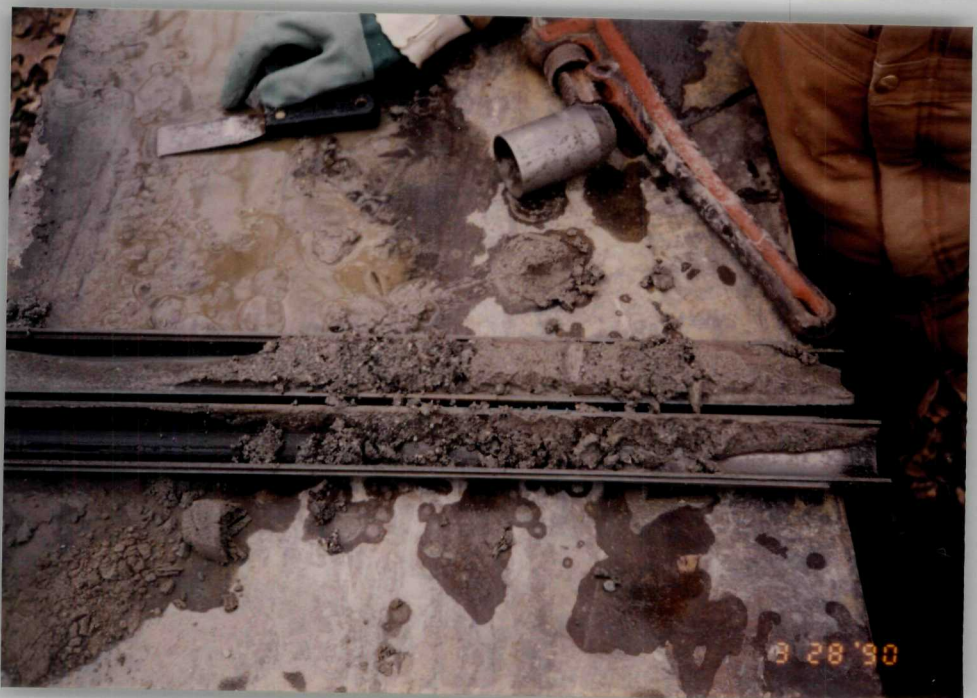
| Number | Description | Date |
|---|--|---|
| R13-19 | Split spoon sample of MW-10, 10 to 12 feet. | 3/28/90 |

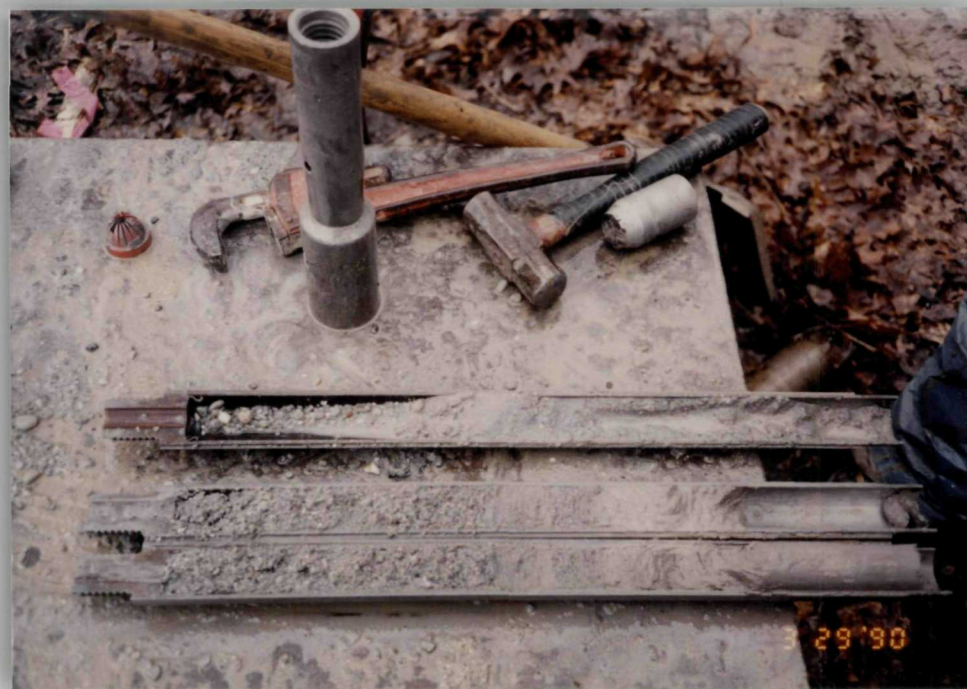
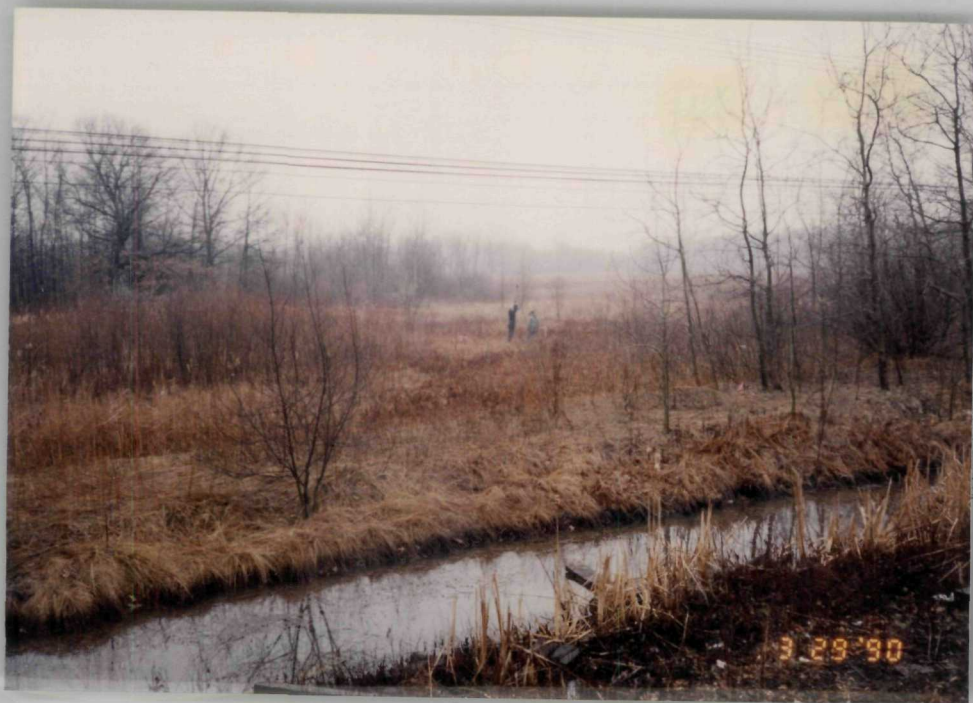
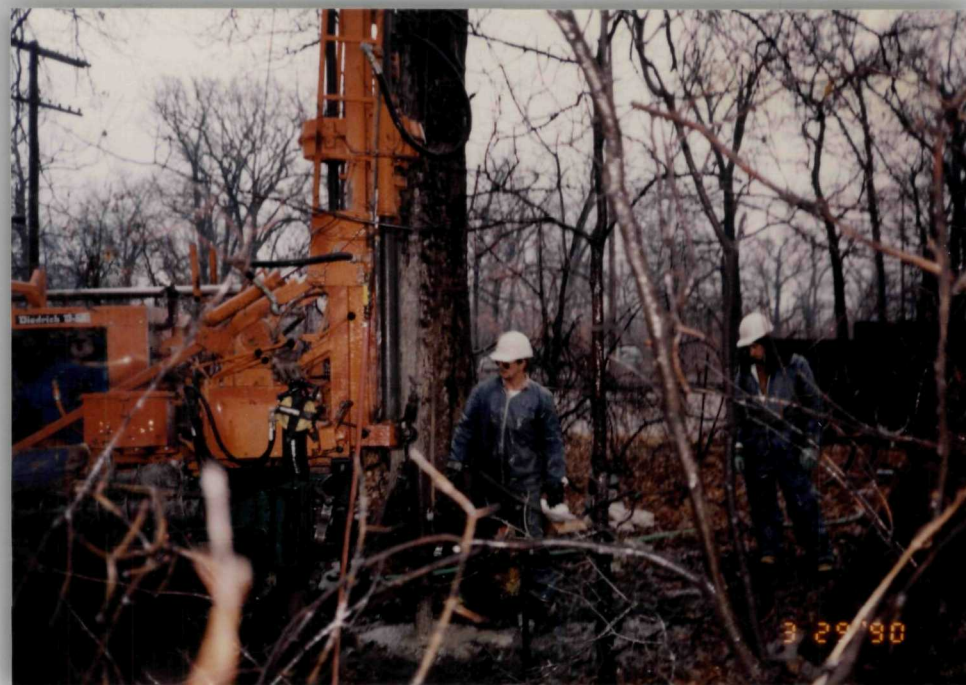
| Number | Description | Date |
|---|--|---|
| R13-23 | Top - split spoon sample of MW-11, 17 to 19 feet; bottom complete split spoon sample of MW-11, 19 to 21 feet; note, bottom 8" gray clay. | 3/29/90 |

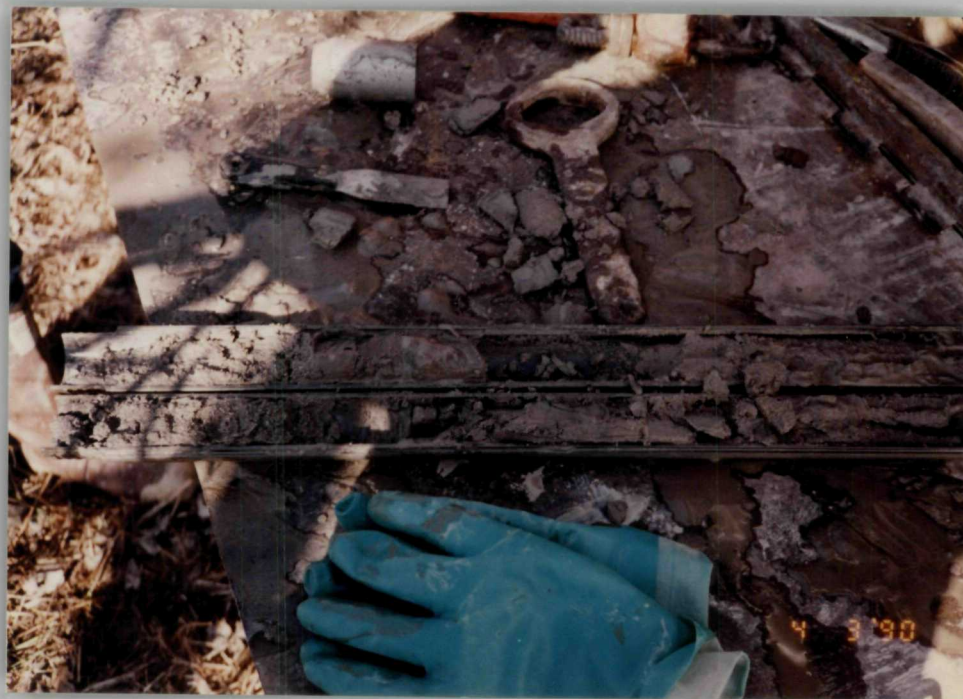
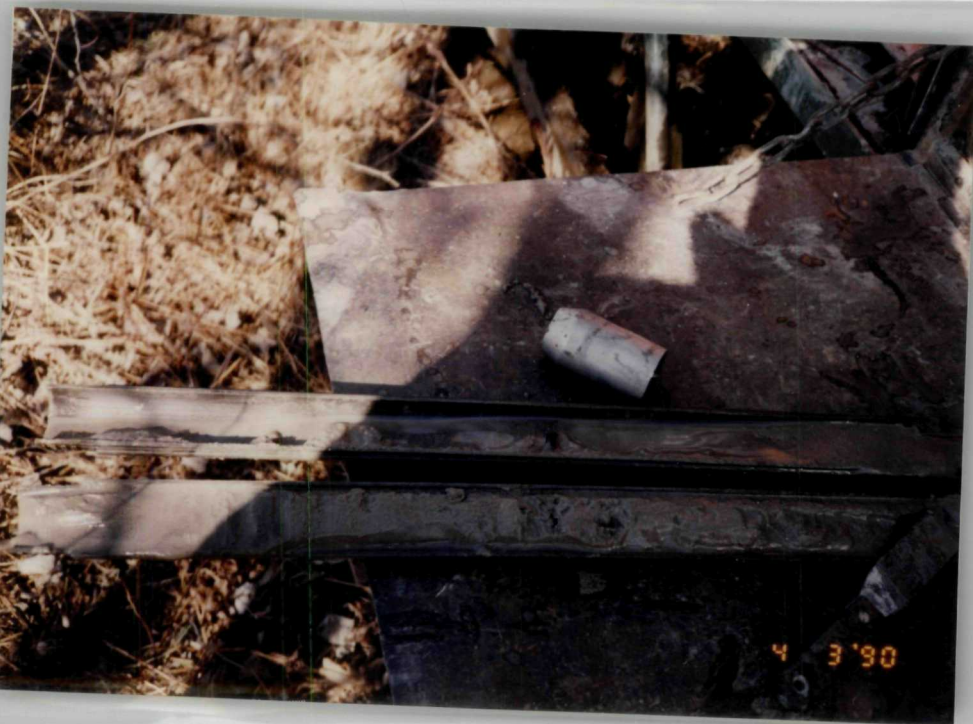
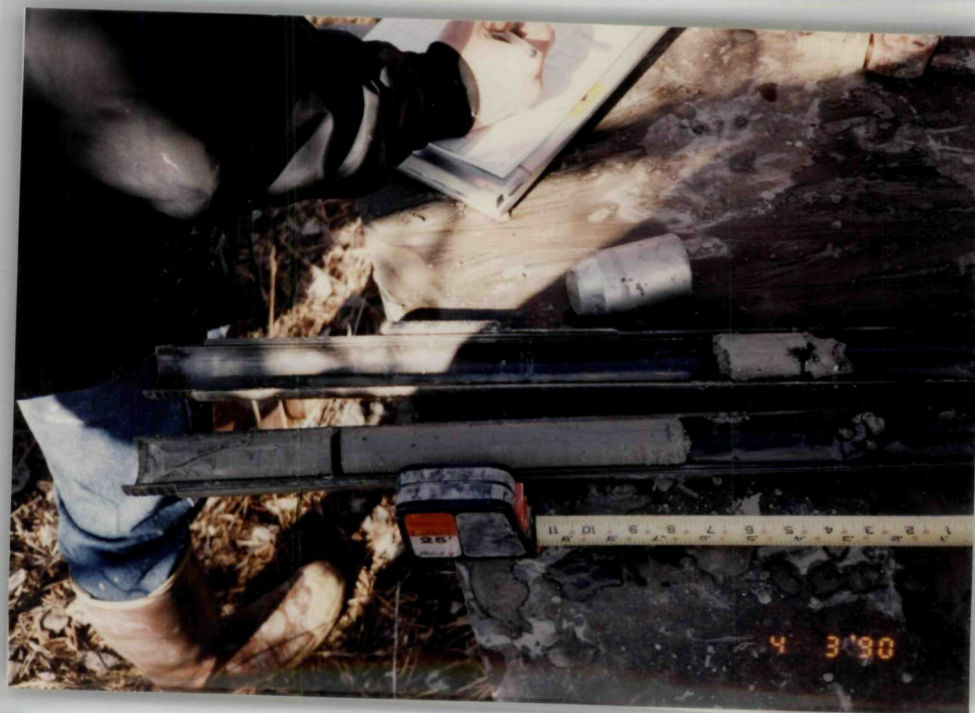
| <u>Number</u> | | <u>Date</u> |
|---|---|---|
| R15-3 | Split spoon sample of MW-13, 10 to 23 feet | 4/03/90 |

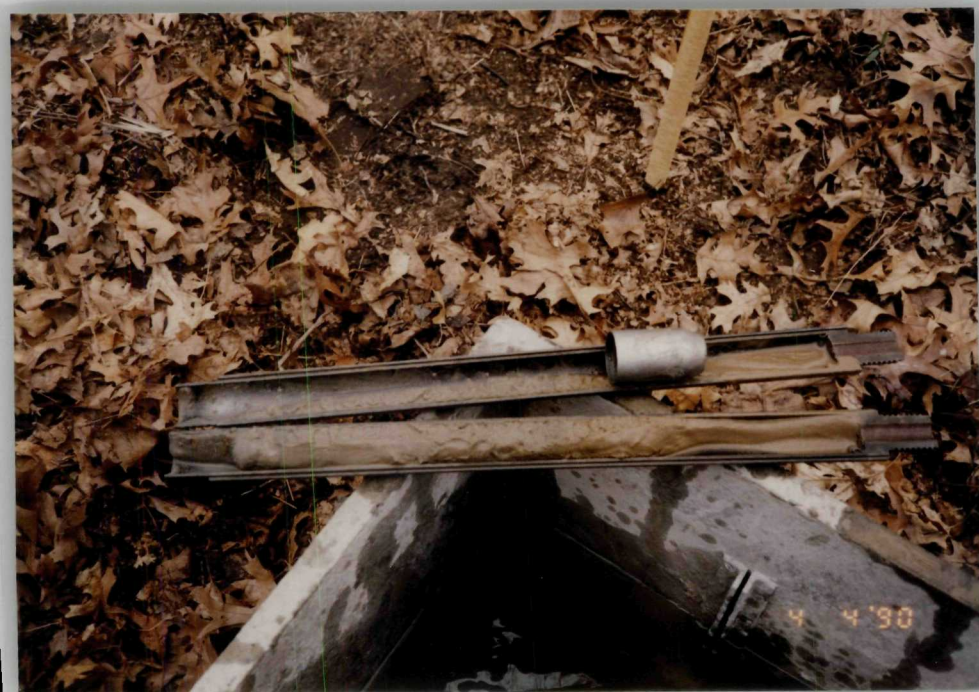
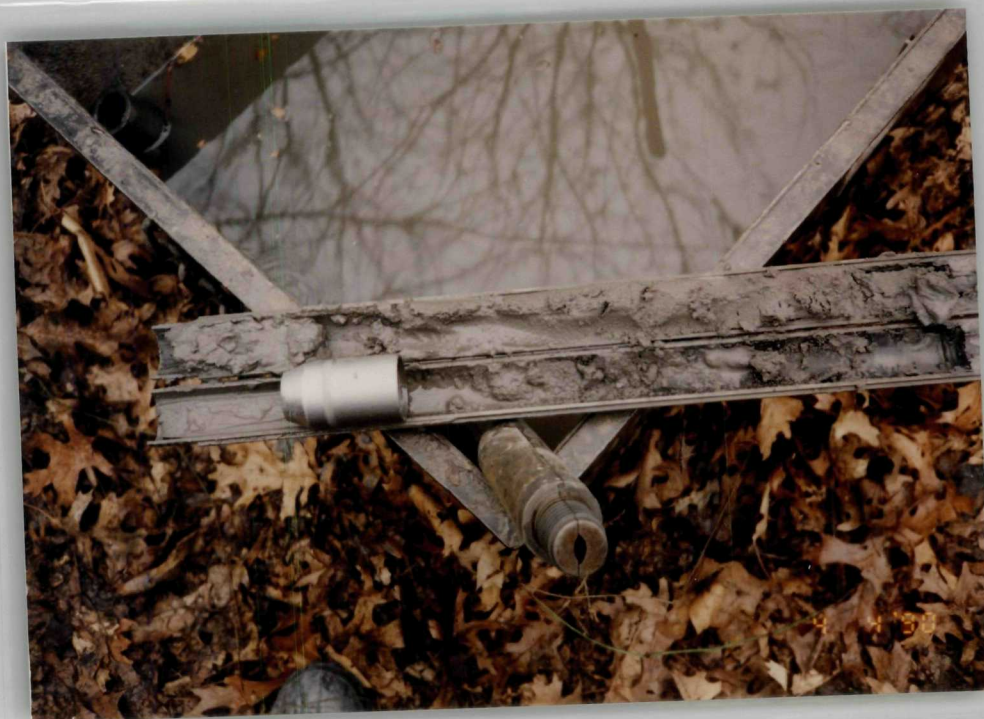
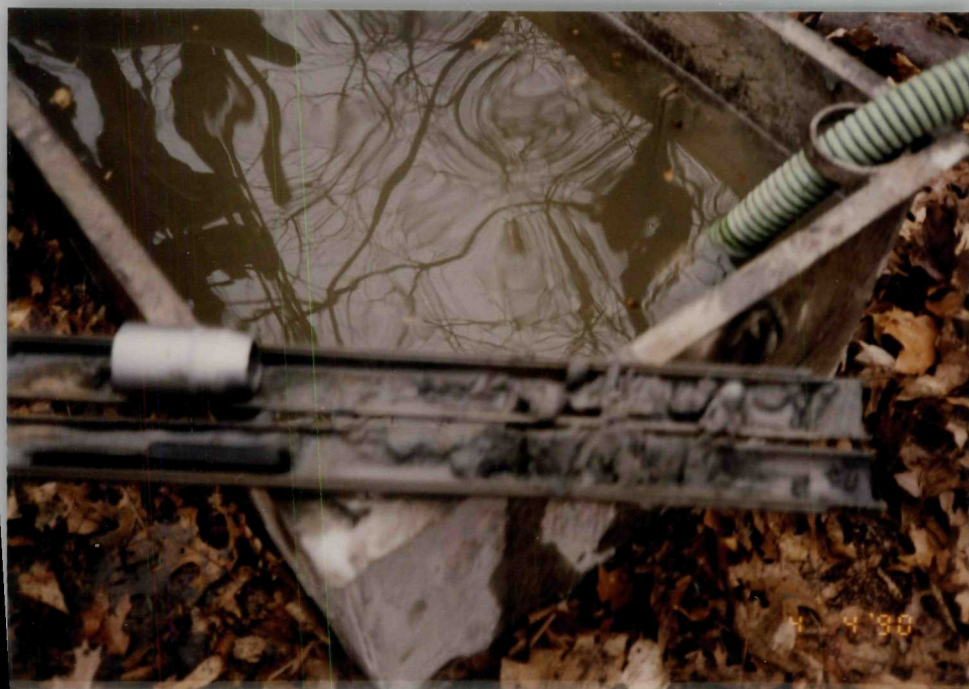
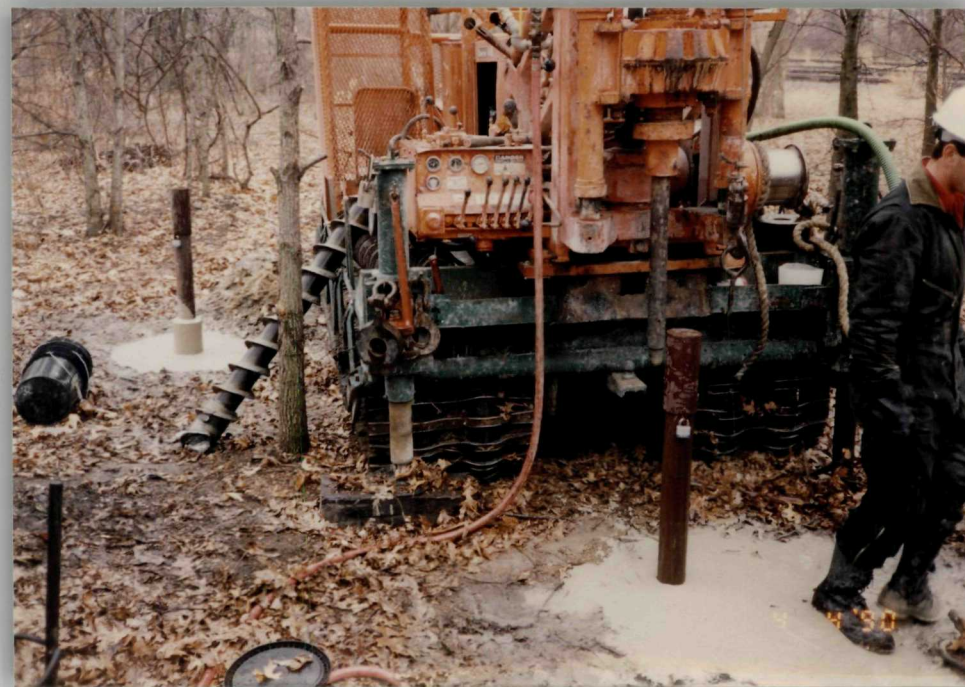
| <u>Number</u> | | <u>Date</u> |
|---|---|---|
| R15-7 | Split spoon sample of MW-14, 15 to 17 feet, note clay encountered at 16.8 feet | 4/04/90 |

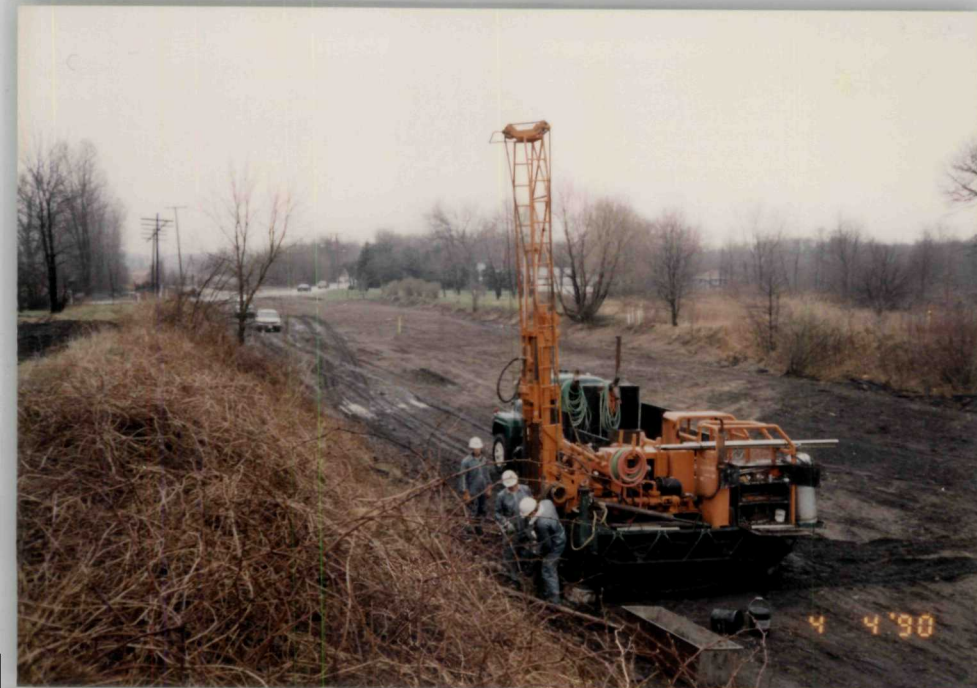
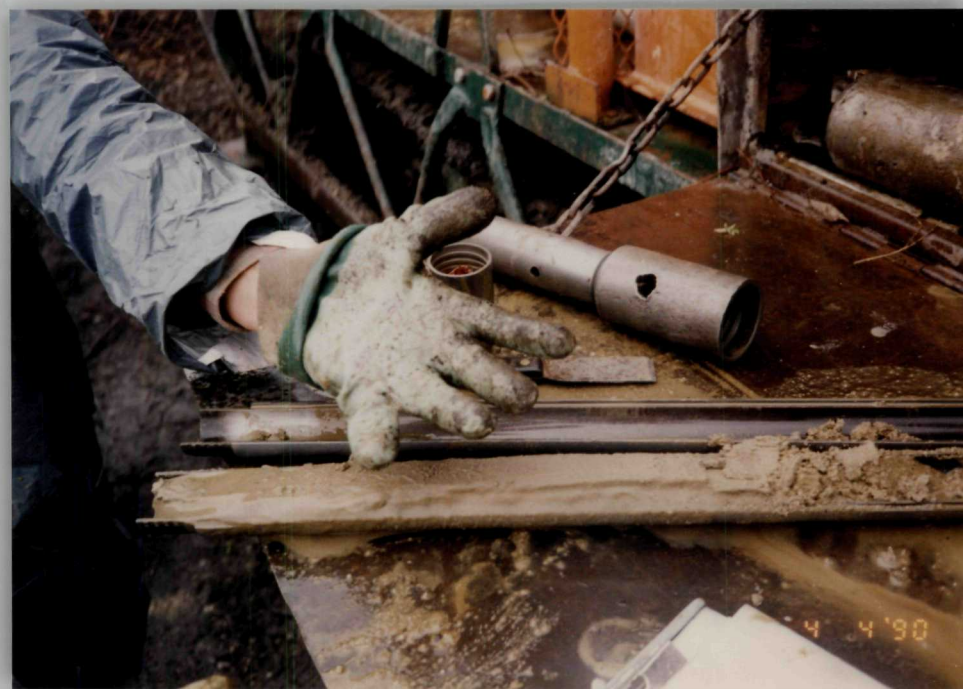
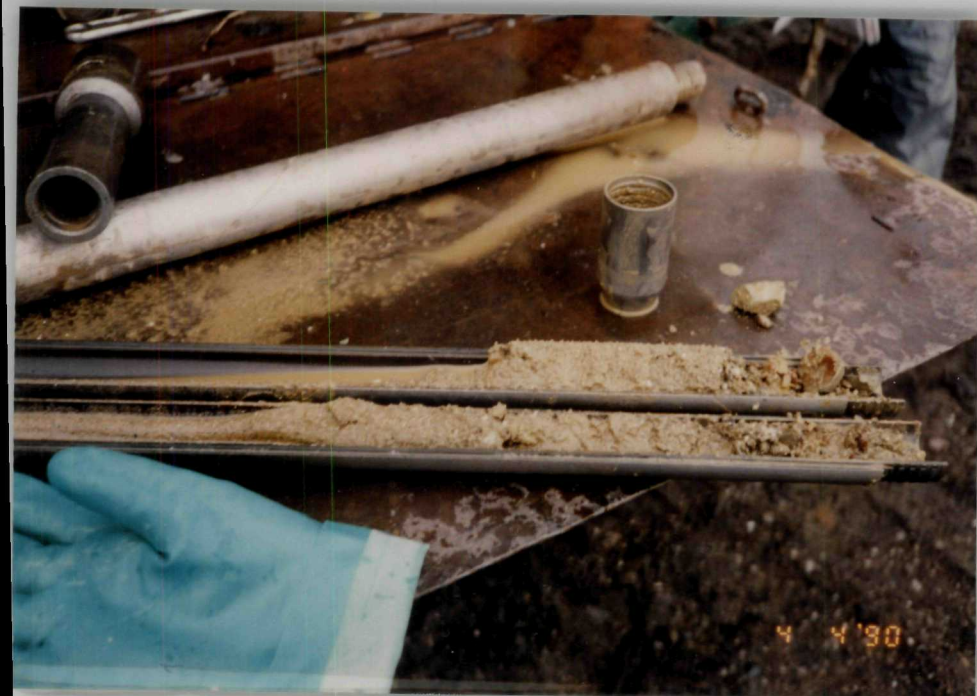
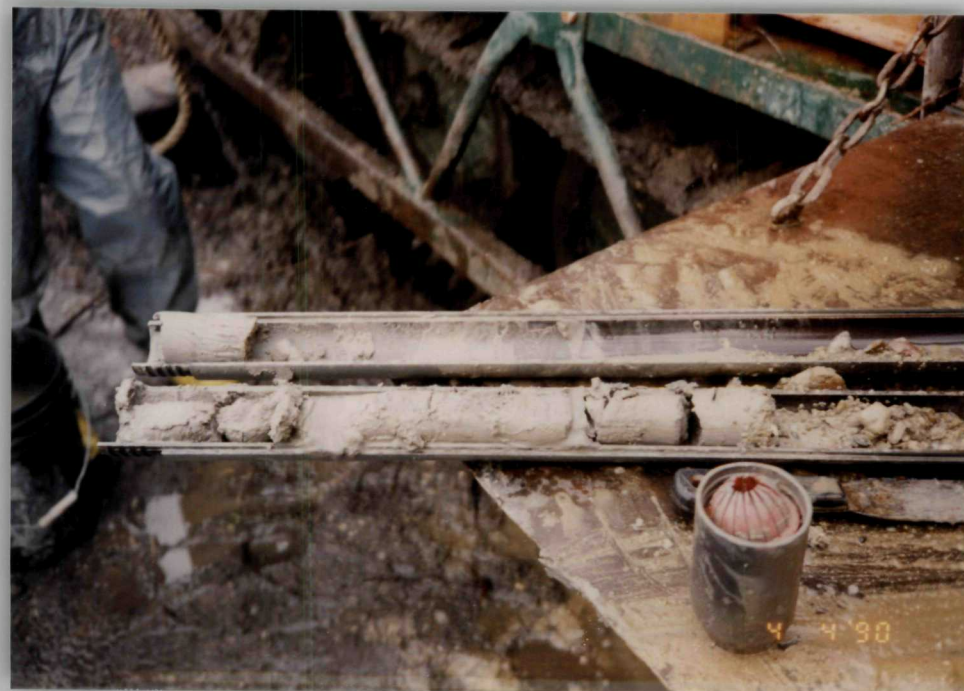
| <u>Number</u> | | <u>Date</u> |
|---|---|---|
| R15-11 | Split spoon sample of MW-15, 10 to 12 feet | 4/04/90 |

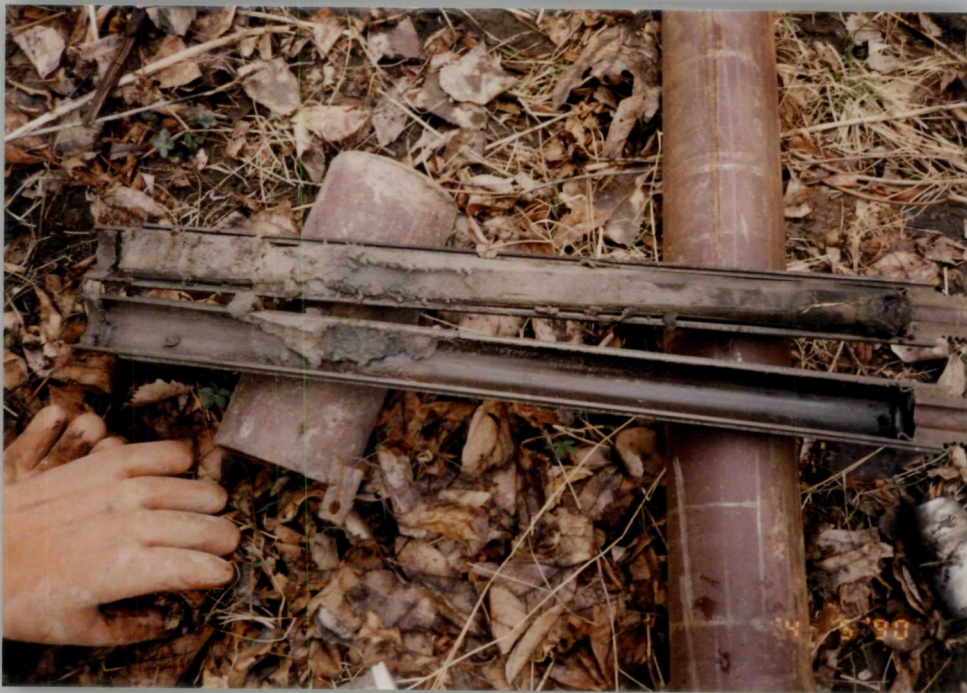
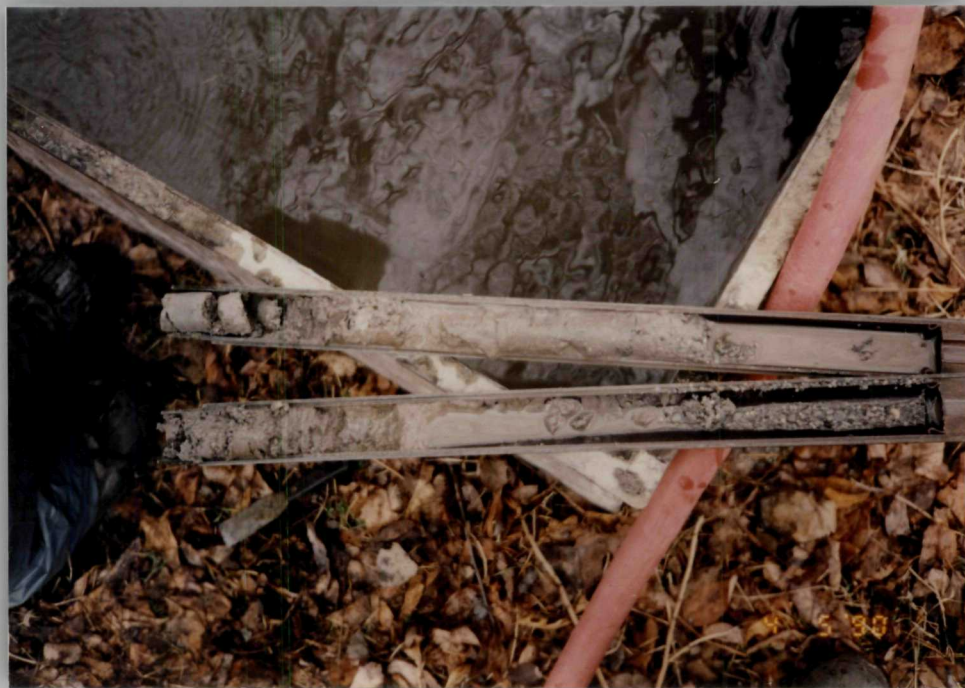
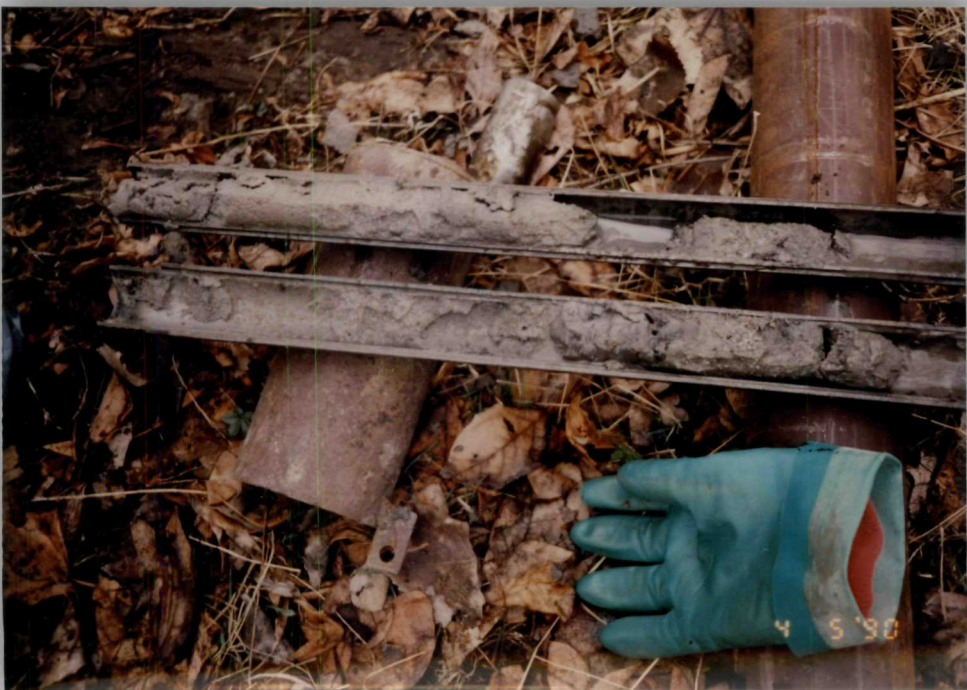
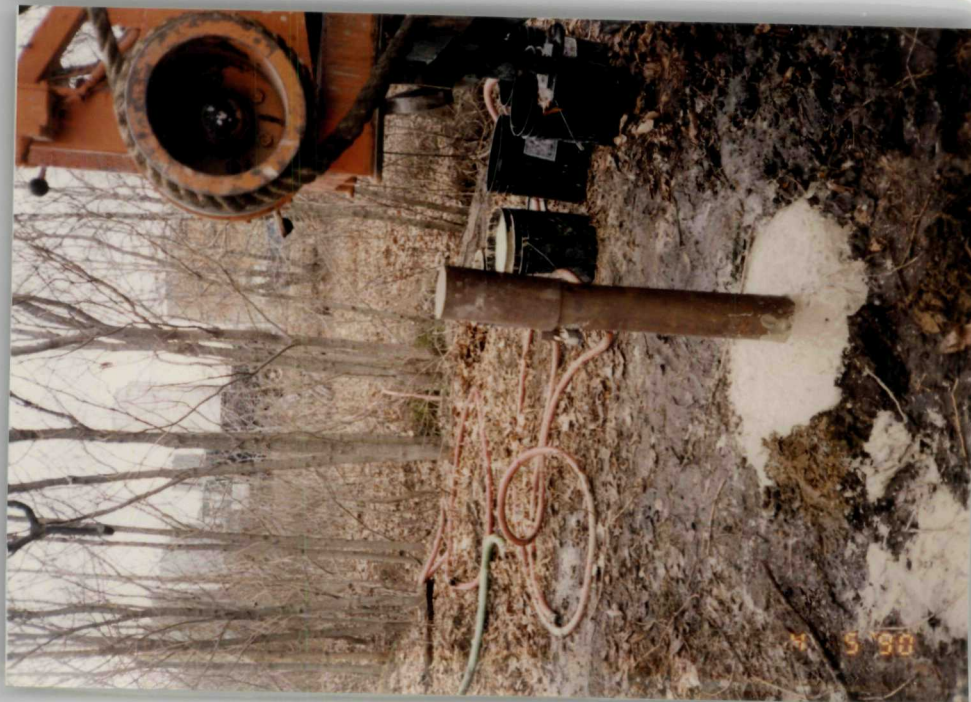
| <u>Number</u> | | <u>Date</u> |
|---|---|---|
| R15-15 | Split spoon sample of MW-16, 15 to 17 feet note clay encountered at 16.8 feet | 4/05/90 |

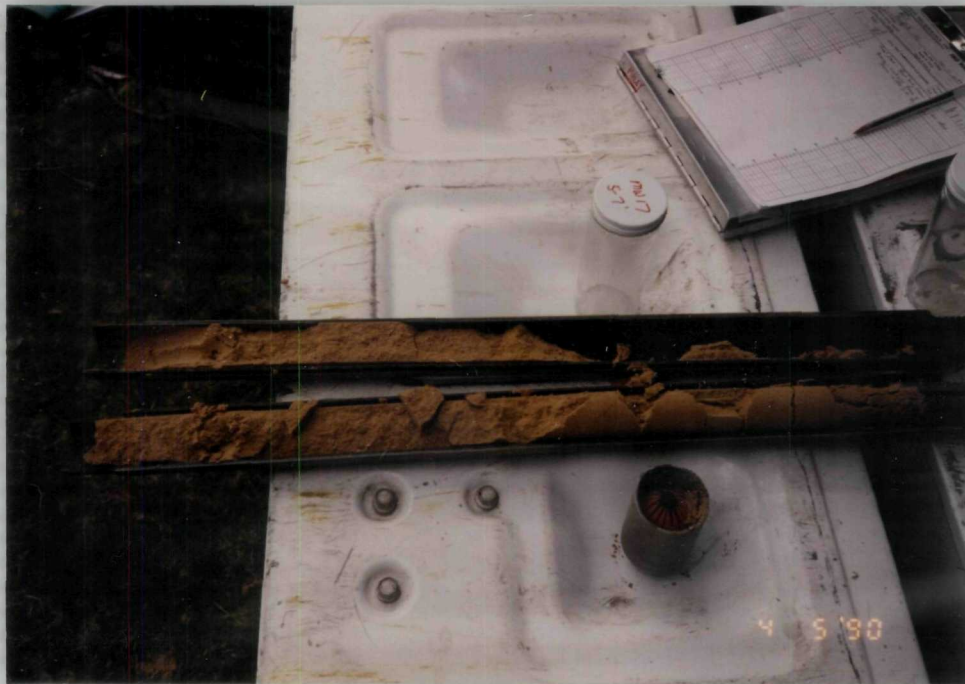
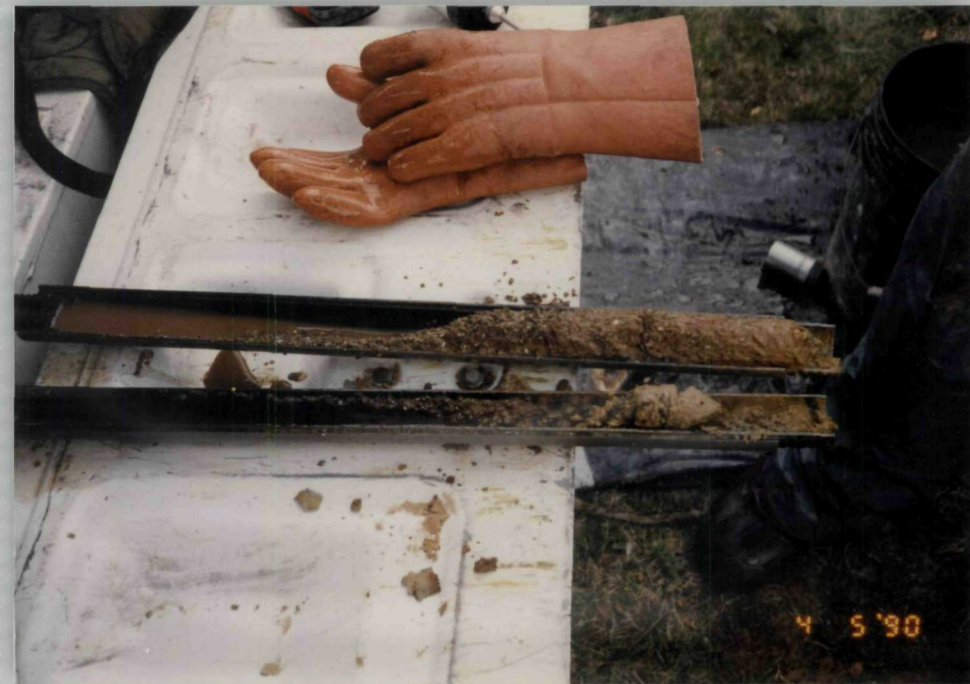
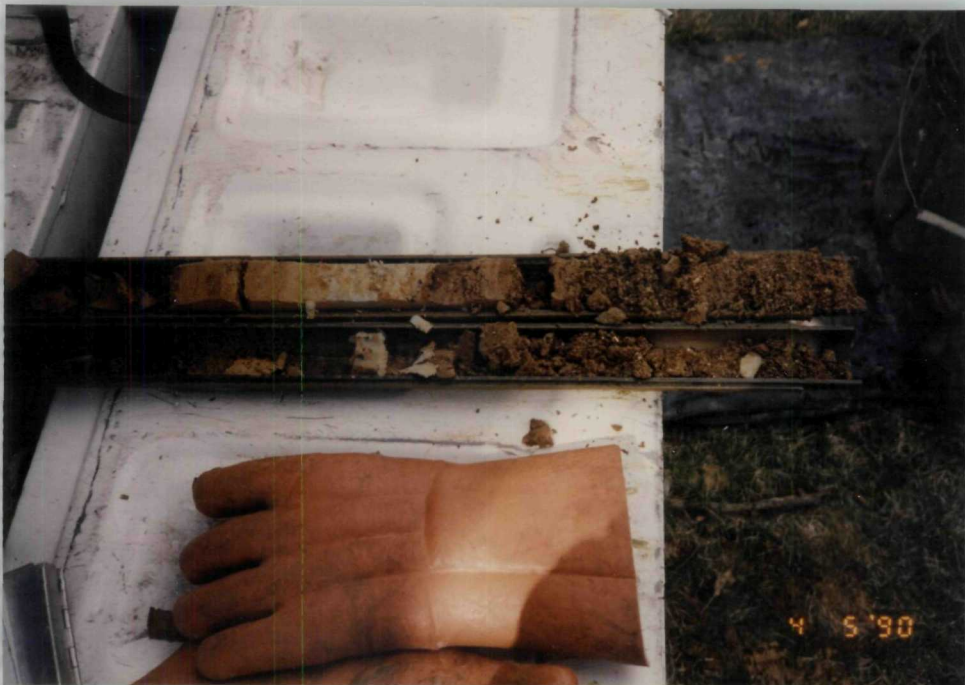
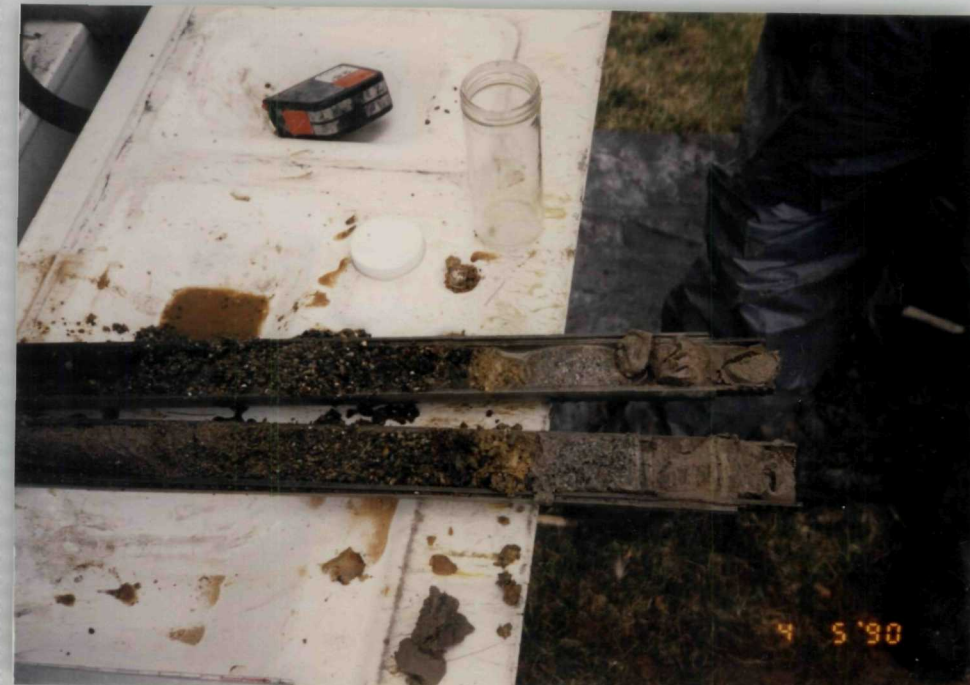
| <u>Number</u> | | <u>Date</u> |
|---|---|---|
| R15-18 | Split spoon sample of MW-17, 10 to 12 feet | 4/05/90 |

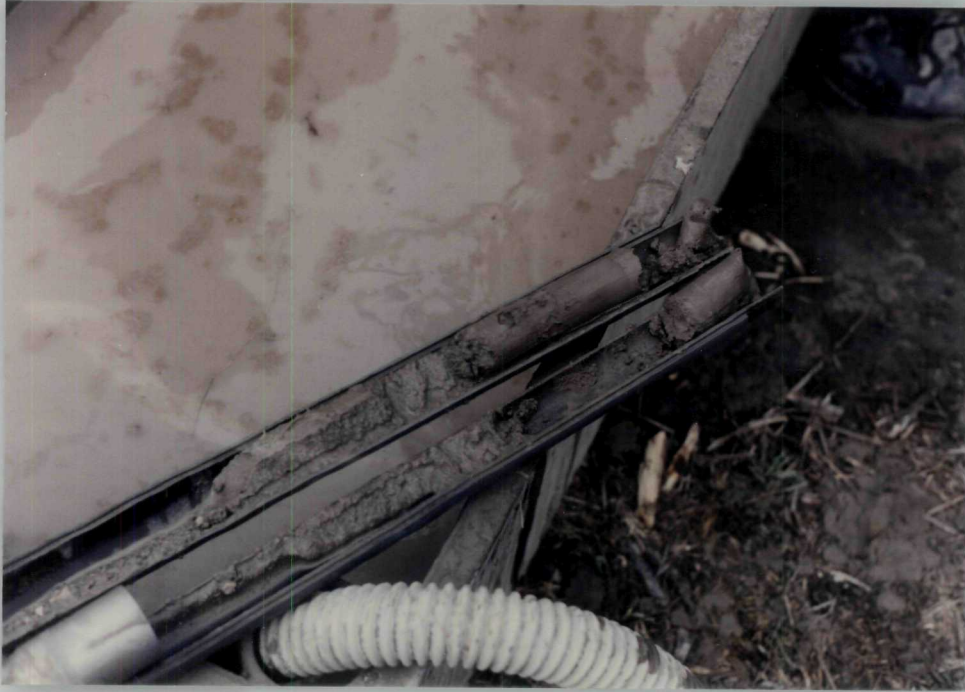
| Photo | Description | Date |
|---|---|---|
| R17-3 | Split spoon sample, well MW-10(D) 19 to 21 feet | 5/1/90 |

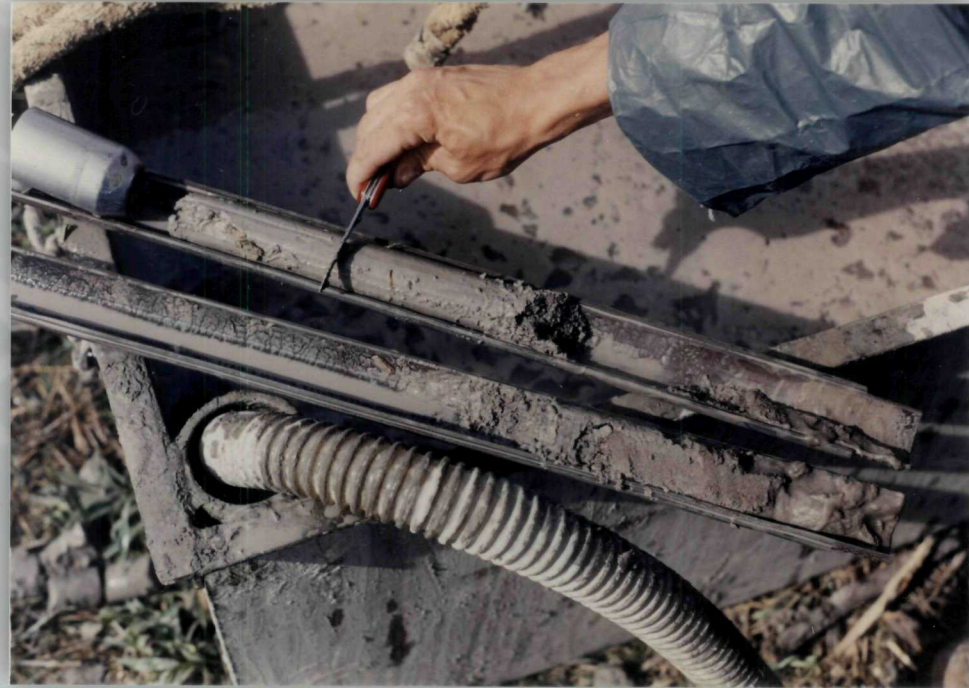
R17-02

| Photo | Description | Date |
|---|---|---|
| R17-2 | Split spoon sample, well MW-10(D) 13 to 15 feet | 4/26/90 |

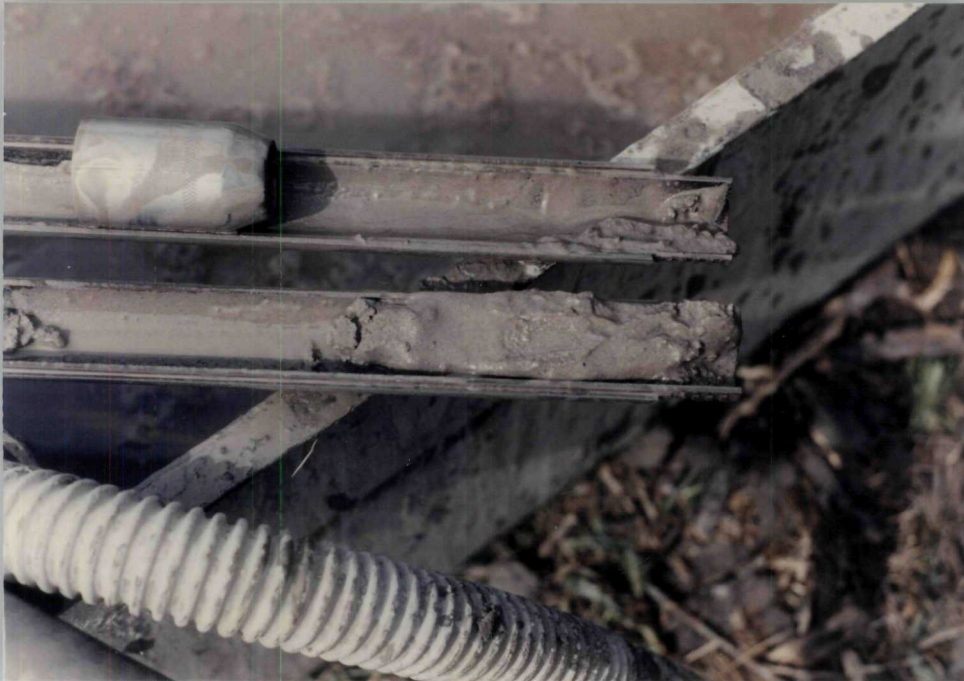
| Photo | Description | Date |
|---|---|---|
| R17-5 | Split spoon sample, well MW-10(D) 23 to 25 feet | 5/1/90 |

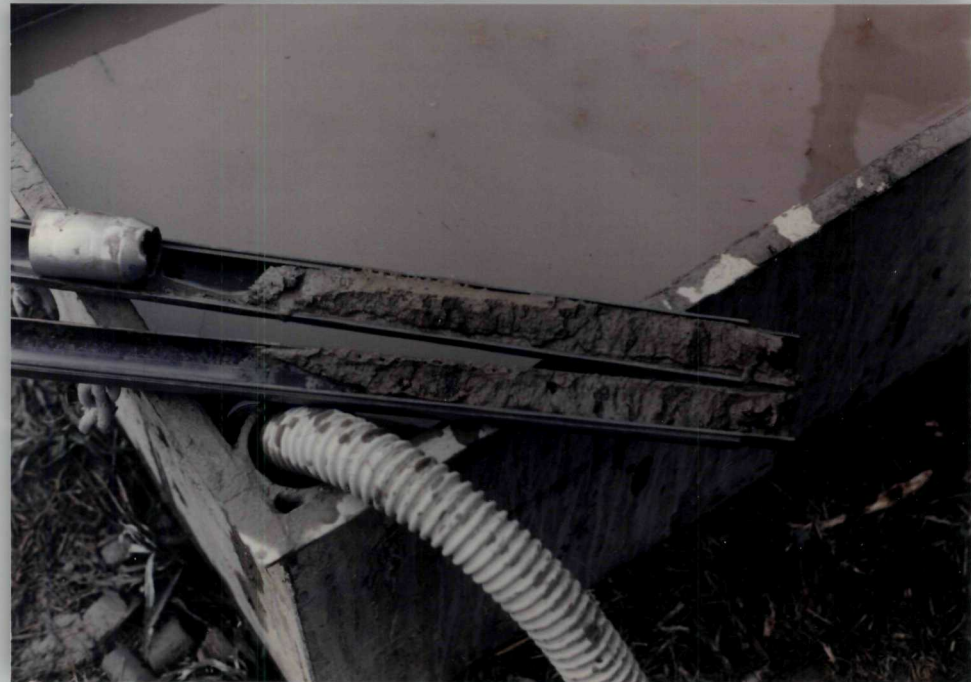
| Photo | Description | Date |
|---|---|---|
| R17-4 | Split spoon sample, well MW-10(D) 21 to 23 feet | 5/1/90 |
